DeJong, MJ, Giardina, G, Chalmers, B, Lazarus, D, Ashworth, D & Mair, RJ 2019, 'Impact of the Crossrail tunnelling project on masonry buildings with shallow foundations', *Proceedings of the ICE - Civil Engineering*, vol. 172, no. 5, pp. 402-416. <https://doi.org/10.1680/jgeen.18.00178>

Manuscript title: The impact of the Crossrail tunnelling project on masonry buildings with shallow foundations

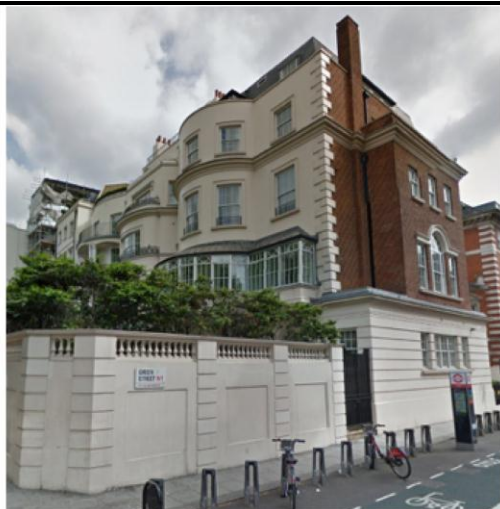
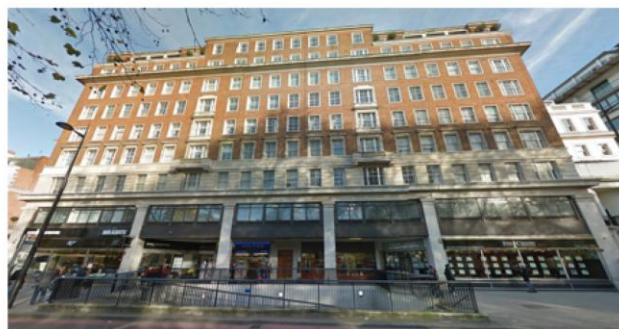
Fig. 2.

Park Lane is situated on the boundary of Hyde Park (Figure 1). The row of houses including 129-133 Park Lane will be considered as a single connected building (Figure 2a), which is located on the east side of Park Lane and includes the addresses on 22 Dunraven Street behind. The building is constructed of load-bearing masonry and comprises four floors and a single basement from the original construction c1757-8, with later extensions including attic floors which were added in the 19th century. They are assumed to have shallow ground-bearing foundations consistent with their age of construction.

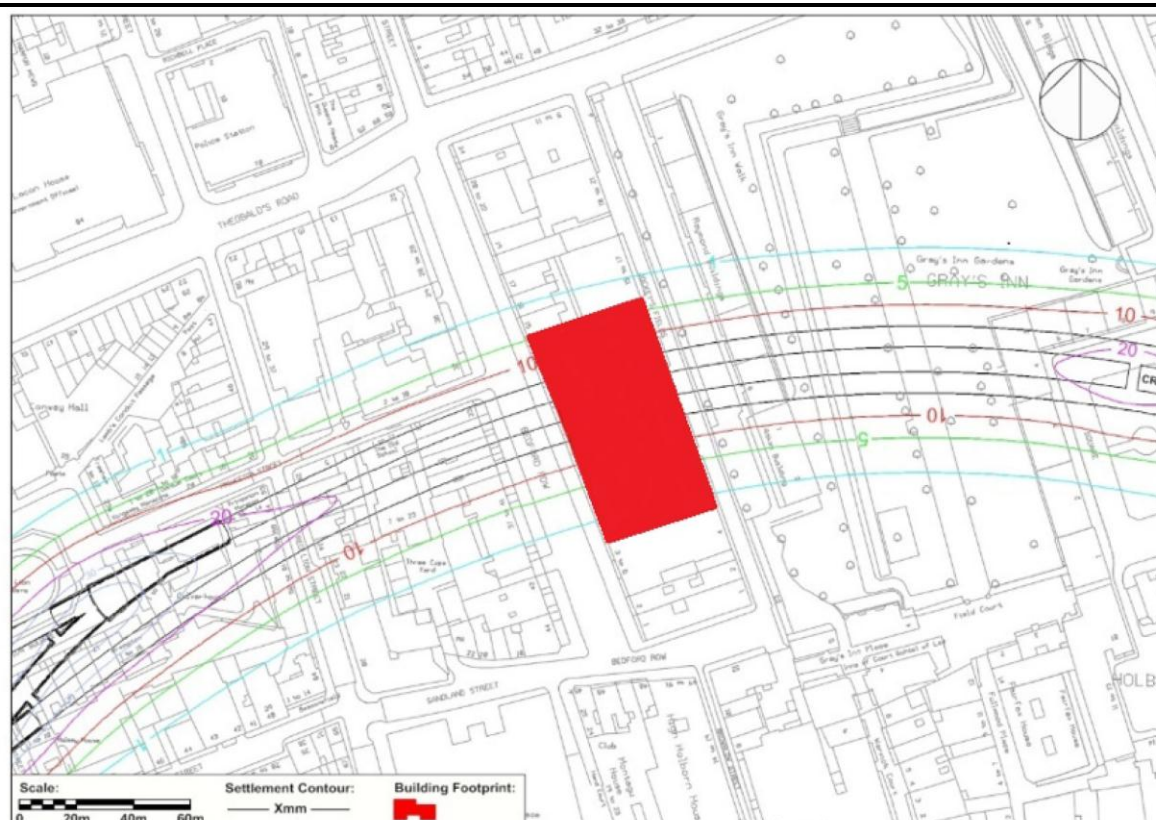
Fig. 4.

volume loss greenfield prediction. Further, the three BRE points installed towards the southern end of the structure also correspond well to the PLP transects. It could be reasonably assumed that the rest of the structure would also follow the PLP transect, although more monitoring points along the structure would be required to confirm this. If this were the case, the data suggests that the structure is relatively flexible and did not alter the expected greenfield settlements significantly. It should also be noted that 6-14 Bedford Row belongs to a longer building terrace. The extent of the selected building approximately corresponds with the 1 mm settlement limit (Figure 4).

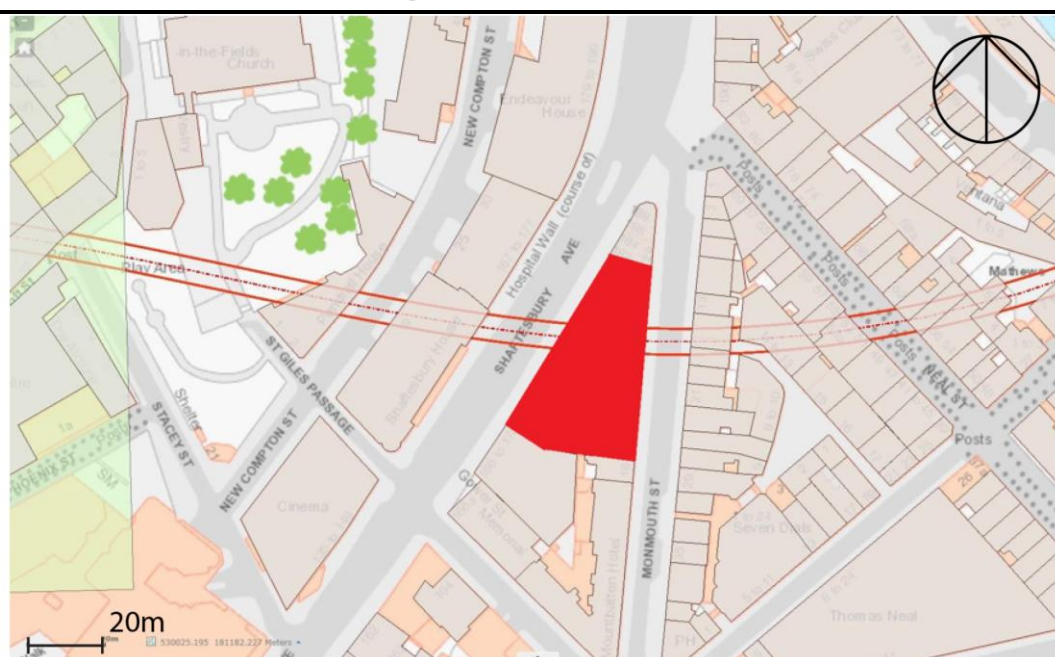
Fig. 7.

Figure 7. Location plan for 172-184 Shaftesbury Avenue (shaded in red). The eastbound tunnel is shown in red and travels directly beneath 172-176 Shaftesbury Avenue.

The terrace properties 172-184 Shaftesbury Avenue form a triangular building that lies above the eastbound tunnel (Figure 7). It comprises two smaller properties and Shaftesbury Hospital (172-176), which extends through to Monmouth Street behind. The buildings have a basement, and the hospital has five storeys above ground while the surrounding buildings have four storeys (Figure 8). The buildings are load bearing masonry and date from pre-1900. The Hospital opened in 1867 and was converted to a hotel sometime after 1992 when it closed as a medical facility. As for Bedford Row, the analysed buildings are approximately defined by the 1 mm settlement line.

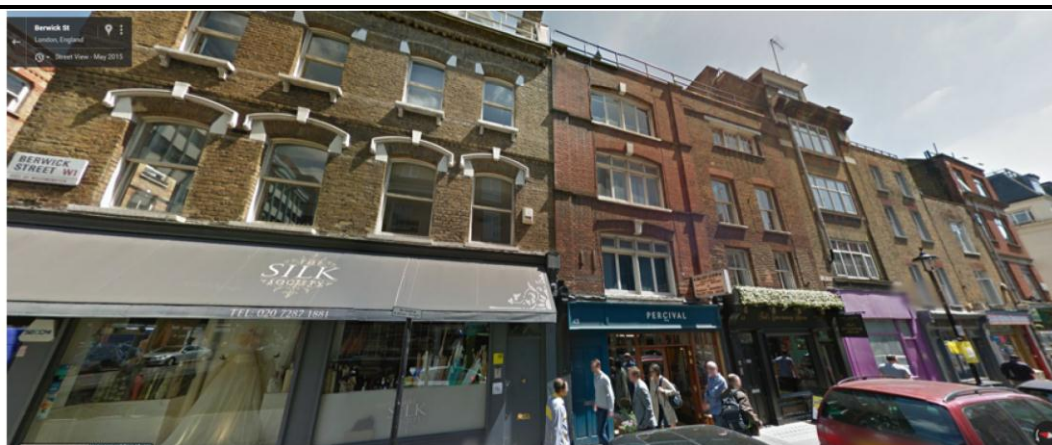
Fig. 11.

The terrace of properties on the east side of Berwick Street (Figure 10) dates from pre-1900 with later additions and alterations. The properties are three to five storeys (see Figure 11), and have a single level of basement.
